INDOOR AIR QUALITY ASSESSMENT

Milton L. Fuller Elementary School 4 School House Road Gloucester, MA 01930

Prepared by:
Massachusetts Department of Public Health
Center for Environmental Health
Bureau of Environmental Health Assessment
Emergency Response/Indoor Air Quality Program
March 2005

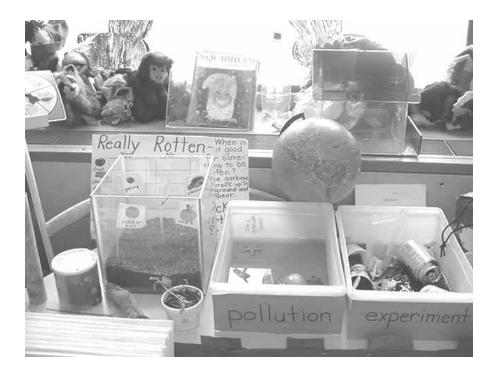
Fresh air in classrooms is supplied by a unit ventilator (univent) system. A univent draws air from outdoors through a fresh air intake located on the exterior wall of the building and returns air through an air intake located at the base the unit (Figure 1). Fresh and return air are mixed, filtered, heated and provided to classrooms through an air diffuser located in the top of the unit. Some univents were off at the time of assessments. Obstructions to airflow, such as papers and books stored on univents and items placed in front of univent returns, were also observed in a number of classrooms (Picture 1). In order for univents to provide fresh air as

Blockages to univent

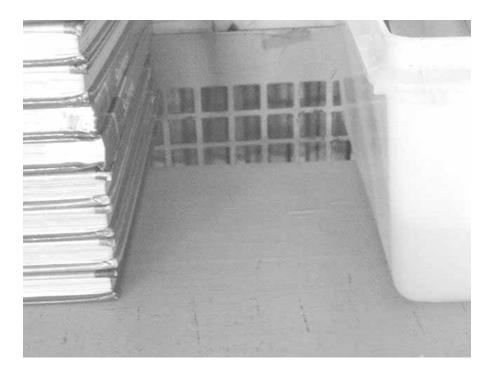
Mechanical exhaust ventilation is provided by wall-mounted or floor level vents powered by rooftop fans. The exhaust system was functioning at the time of assessment; however, obstructions were noted in some areas (Picture 2 and 3). One exhaust vent was also sealed with tape (Picture 4). As with univents, exhaust vents must remain free of obstructions and allowed to function as designed. It is important to note that the location of some exhaust vents can limit exhaust efficiency. In some areas, the exhaust ventilation function is hindered by the proximity of vents to hallway doors (Picture 5). When classroom doors are open, exhaust vents will tend to draw air from both the hallway and the classroom, reducing the effectiveness of the exhaust vent to remove common environmental pollutants. Without sufficient supply and exhaust ventilation, environmental pollutants can build up, leading to indoor air quality complaints.

Obstructions to wall-mounted exhaust vent

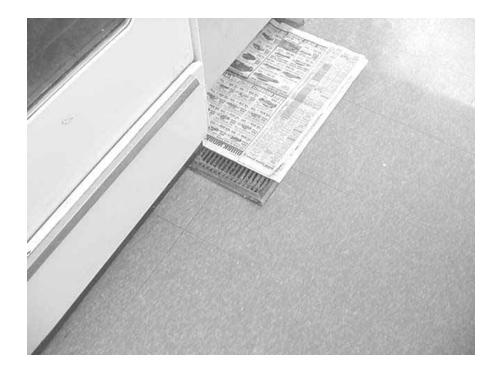
Obstructions to floor level exhaust vent

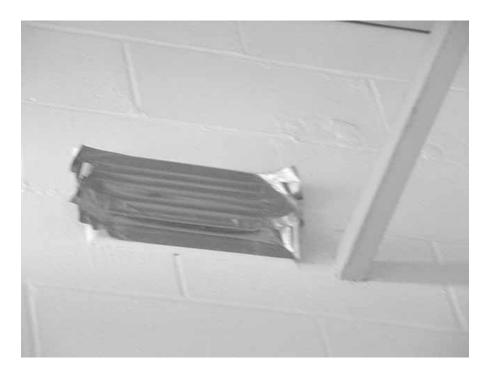
Wall-mounted exhaust vent sealed with duct tape

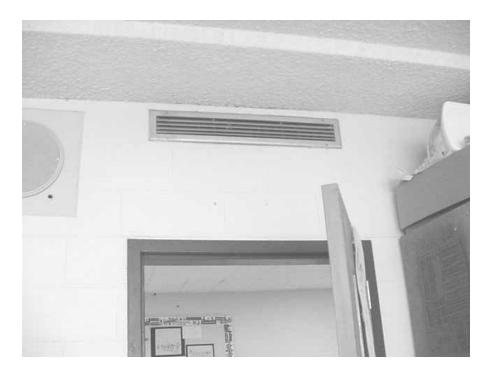
Exhaust vent located above hallway door

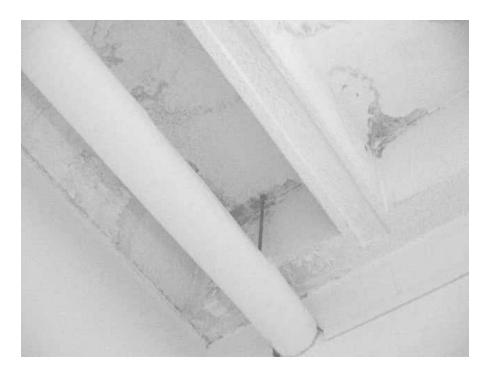
Water-damaged ceiling plaster and ceiling tiles were observed in some areas of the school (Pictures 6 and 7). Such damage is an indication of a roof or pipe leak. As reported by school officials, roof problems are related to the roof membrane integrity. Most water damage to ceiling components at the FES is likely related to water penetration around skylights. Water penetrating through skylight panels or the roof membrane has resulted in damage to ceiling plaster and beams (Picture 8). Although water-damaged ceiling plaster is not a source for mold growth, moistened dust trapped in spaces between the paint and brick can become mold growth media. Water-damaged ceiling plaster can be cleaned with an appropriate agent (e.g. bleach and water solution). Water-damaged ceiling tiles can provide a source for mold growth and should be replaced after a water leak is discovered and repaired.

Water damage to ceiling plaster and beams

- day can help ease some symptoms associated with a dry environment (throat and sinus irritations).
- 8. Replace water-damaged ceilings and repair building materials. Examine these areas for mold growth. Disinfect areas of water leaks with an appropriate antimicrobial. Remove water-damaged materials in a manner consist with *Mold Remediation in Schools and Commercial Buildings* published by the US EPA (2001). This document can be downloaded from the US EPA website: http://www.epa.gov/iaq/molds/mold remediation.html.

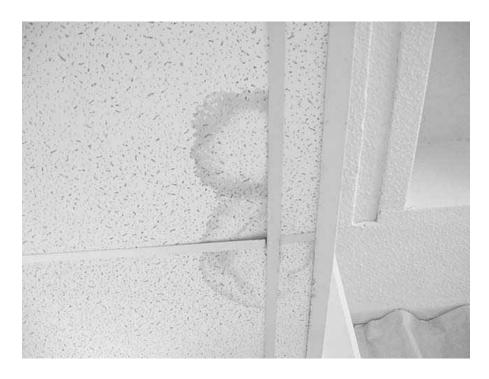
Water-damaged ceiling tile

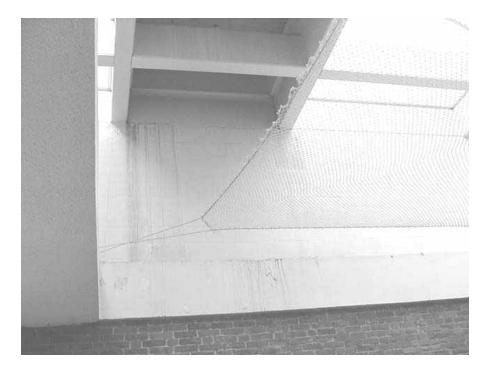
Water damage resulting from skylight leak

- 11. Repair/replace the roof membrane and seal breaches around the skylight to prevent further damage.
- 12. Remove debris and ensure proper drainage in the exterior stairwells and subterranean pits.

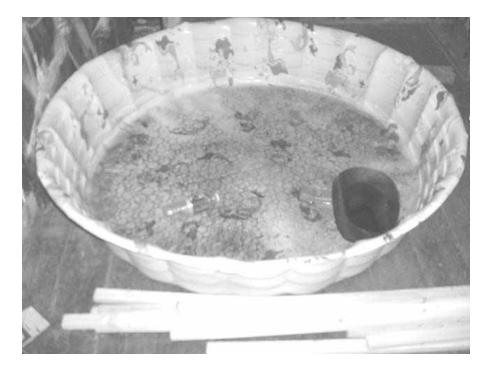
A roof leak was also noted in the stage area of the auditorium. BEHA staff found a wading pool that appeared to be used to collect water. The pool contained stagnant water and

debris (Picture 9). The pool should be emptied and cleaned periodically to prevent odor and growth, until measures can be taken to repair/replace the roof membrane.

Stagnant water in pool from roof leak in auditorium, note debris in basin

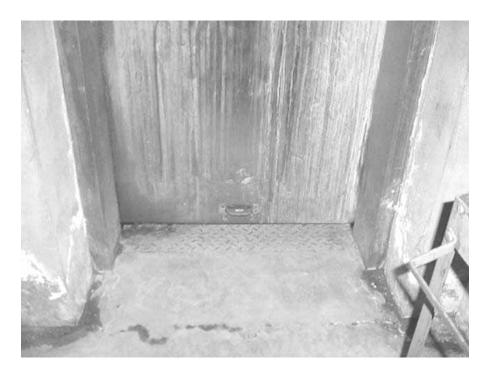
According to school personnel, the FES also experienced flooding in the boiler/basement areas. School personnel reported musty odors in this area. Signs of water damage (e.g., efflorescence) were noted near the entry doorway to the boiler room (Picture 10). Standing water and water-damaged materials were also noted in the boiler area (Picture 11). Standing water and water-damaged materials can serve as a source for microbial growth. Efflorescence was also observed in boiler/basement areas. Efflorescence is a characteristic sign of water damage to building materials such as cement or plaster, but it is not mold growth. As moisture penetrates and works its way through exterior wall, water-soluble compounds dissolve, creating a solution. As the solution moves to the surface of the interior wall, water evaporates, leaving behind white, powdery mineral deposits.

Efflorescence in boiler room stairway

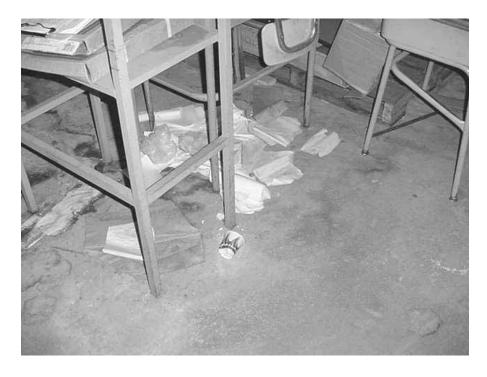
Water-damaged materials

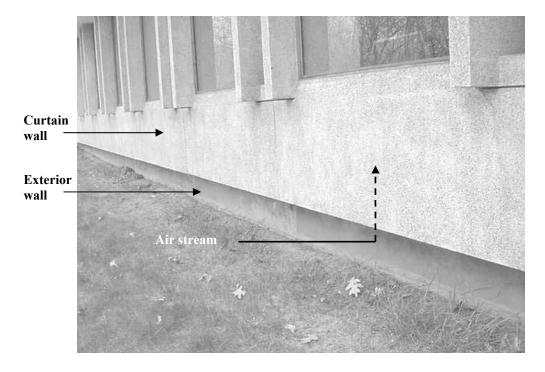
Exterior wall configuration and univent fresh air intake

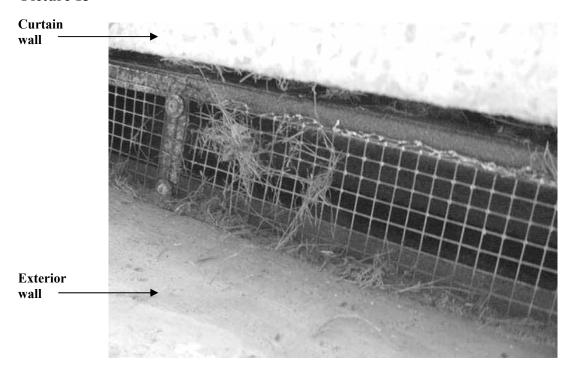
Picture 13

Space between which fresh air is drawn into univent, grate installed to prevent pest entry

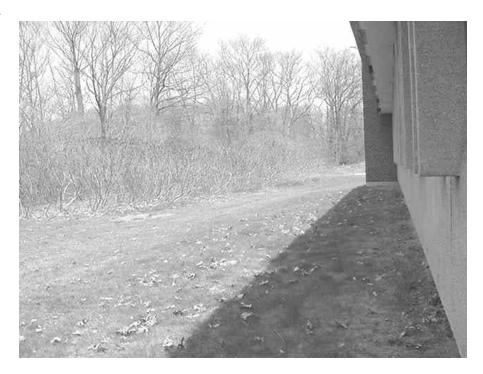
- Wing location: The wing is immediately adjacent to a forested area (Picture 14). The trees and shade provided by the building prevent the sun from drying soil around the exterior wall of the wing. In addition, the ground at the base of the wing was covered with leaves and grass clippings, which prevents soil from drying. If repeatedly moistened, leaves and pine needles can also become mold growth medium.

Forest area adjacent to school

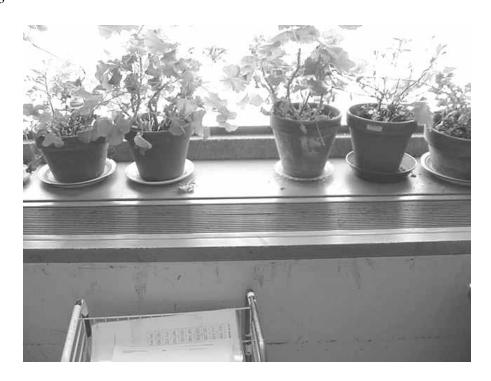
Plants and potted soil were located in several classrooms. In some classrooms, plants were found on top of univents and other mechanical equipment (Picture 15). Plants, soil and drip pans can serve as sources of mold growth. Plants should be properly maintained, over-watering of plants should be avoided and drip pans should be inspected periodically for mold growth. Plants should also be located away from ventilation sources to prevent aerosolization of dirt, pollen or mold.

Plants on univents

- 13. Move plants away from univents in classrooms. Ensure all plants are equipped with drip pans. Examine drip pans for mold growth and disinfect areas of water leaks with an appropriate antimicrobial where necessary. Consider reducing the number of plants.

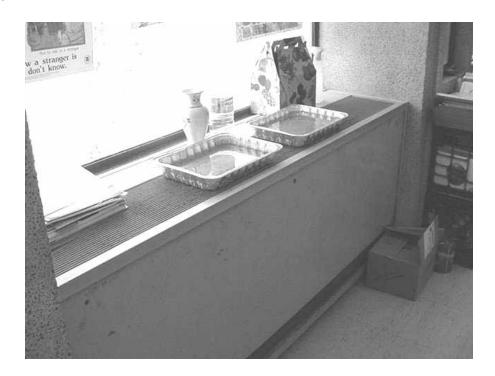
Stagnant water is also a source for microbial growth. Pans with standing water were observed on top of univents (Picture 16). The water in these pans can serve as a source of

microbial growth. Moreover, the univent may distribute particles and odors from the water. Similarly, humidifiers and dehumidifiers were noted in some classrooms (Picture 17 and 18). Water reservoirs for humidifiers and dehumidifiers should be cleaned as per manufacturer's directions to prevent microbial growth and odors. The water reservoir for one humidifier had noticeable growth (Picture 17). As with univents, humidifiers can aerosolize particles and odors.

Pans of water on univents

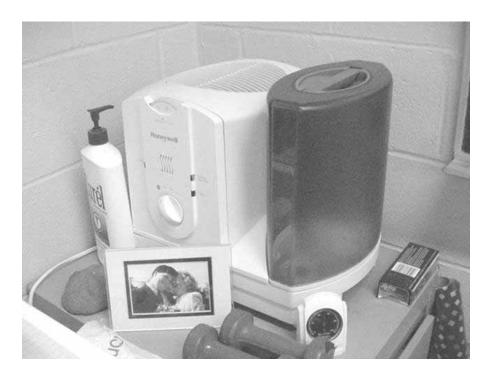
Humidifier, note condition of water well

- 14. Clean dehumidifiers and humidifiers regularly to prevent odor and particulate aerosolization.
- 15. Refrain from using strong-scented materials (e.g. air fresheners).

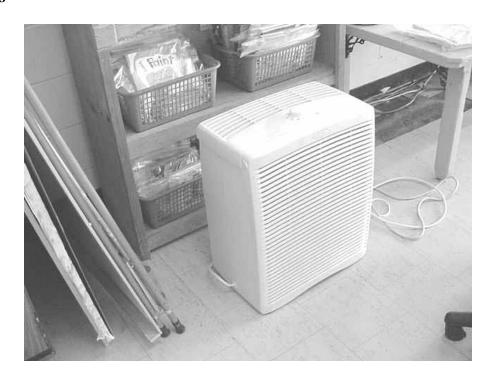
Dehumidifier

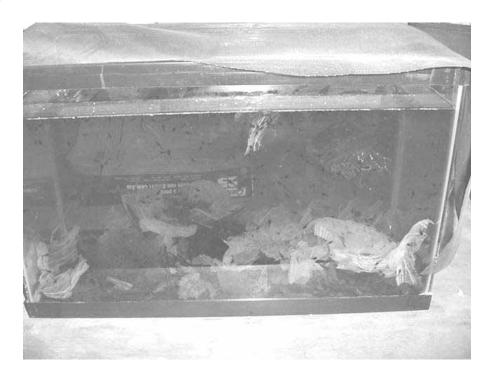
A number of aquariums and terrariums were noted in classrooms (Picture 19).

Aquarium, note conditions of water

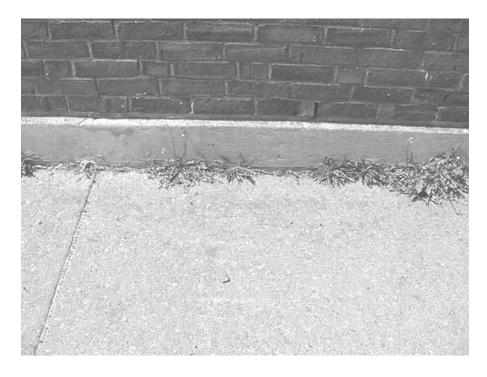
Shrubbery and other plants were growing in close proximity to slab walls (Picture 20). The growth of roots against the exterior walls can bring moisture in contact with wall brick. Plant roots can eventually penetrate the brick, leading to cracks and/or fissures in the foundation below ground level. Over time, this process can undermine the integrity of the building envelope, providing a means of water entry into the building through capillary action through foundation concrete and masonry (Lstiburek & Brennan, 2001).

Plants growth between slabs

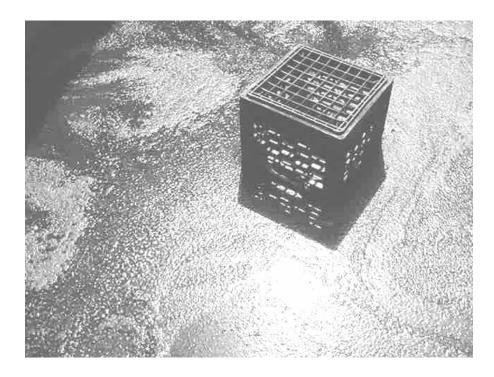
Standing water was noted in a stairwell (Picture 21). Standing water can provide a source for microbial growth and odor production. Pooling water against the building exterior can result in damage to the exterior. Over time, interior portions of the building can also sustain damage.

Standing water in stairwell, note algal growth

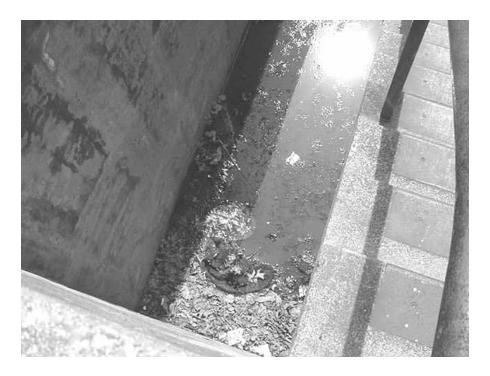
Lastly, leaves and debris were noted in a subterranean pit (Picture 22). When moistened, this material can also become a source for microbial growth and odor. Leaves should be removed to prevent growth and odor production.

Leaf and debris accumulation in subterranean pit

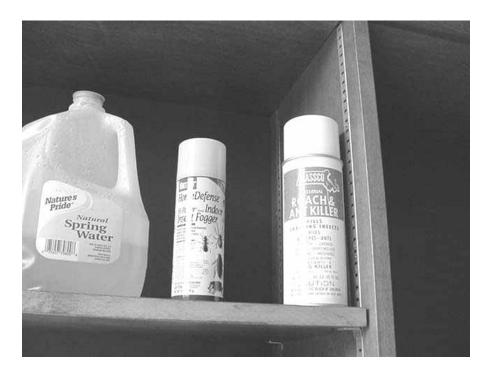
An array of pyrethrin-based insecticides were noted in one room (Picture 23/Table 2). Pyrethrins have been associated with cross sensitivity with individuals who have ragweed allergy (EPA, 1989). Applicators of this product should be in full compliance with the federal and state rules and regulations that govern pesticide use including posting and notification requirements (333 CMR 13.10). Under no circumstances should untrained personnel apply this material. This product should not be applied prior or during school hours. Under current Massachusetts law (effective November 1, 2001), the principles of integrated pest management (IPM) must be used to remove pests in state buildings (Mass Act, 2000). Pesticide use indoors can introduce chemicals into the indoor environment that can be sources of eye, nose and throat irritation.

Insecticides in Office

- 17. Remove insecticides from office and classroom areas. Ensure products are stored and used in an appropriate manner.
- 18. Store rubber cement and household and industrial cleaners in an appropriate manner.
- 19. Contact a licensed member of the GPS maintenance staff or other professional contractor to assess pipe wrapping as soon as practicable.
- 20. Seal all utility holes, wall cracks, breaches and any other possible pathways to prevent the penetration of materials and odors into occupied areas.
- 21. Relocate or consider reducing the amount of materials stored in classrooms to allow for more thorough cleaning. Clean items regularly with a wet cloth or sponge to prevent excessive dust build-up.
- 22. Consider discontinuing the use of tennis balls on furniture and replacing tennis balls with alternative "glides". Refer to Picture 32 for an example of such glides.

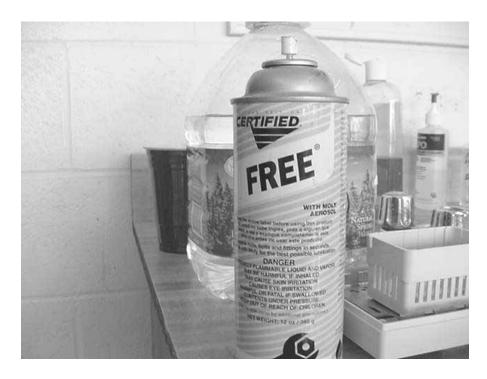
A number of cleaning agents were also observed in classrooms. Aerosol canisters of "Free with Moly" were noted in some classrooms (Picture 24). This industrial strength product contains TVOCs. Citrus-based agents and other cleaning products were also noted on

Aerosol canister of industrial cleaner

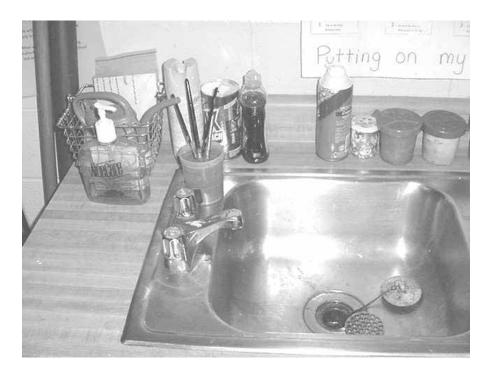
countertops and in unlocked cabinets beneath sinks in some classrooms (Picture 25). Like dry erase materials, cleaning products contain VOCs and other chemicals that can be irritating to the eyes, nose and throat of sensitive individuals. Also of concern are unlabelled bottles and containers. Products should be kept in their original containers and be clearly labeled for identification purposes, especially in the event of an emergency. In addition, air deodorizers were observed in some classrooms. Air deodorizers can mask any naturally occurring odors, which can indicate problems with the ventilation system or odors migrating from adjacent areas.

Cleaners and air deodorizers

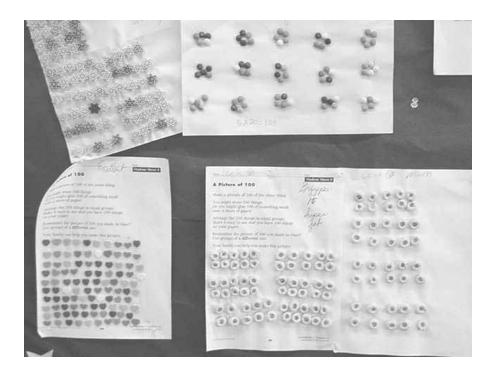
Pest attractants were identified within the building. Food-based projects and re-use of food containers were noted (Pictures 26 and 27). Proper food storage is an integral component in maintaining indoor air quality. Food should be properly stored and clearly labeled. Reuse of food containers is not recommended since food residue adhering to the surface may serve to attract pests.

Food based projects

- c) Stored foods in tight fitting containers.
- d) Avoid eating at workstations. In areas were food is consumed, periodic vacuuming to remove crumbs are recommended.
- Regularly clean crumbs and other food residues from toasters, toaster ovens, microwave ovens coffee pots and other food preparation equipment;
- f) Examine each room and the exterior walls of the building for means of rodent egress and seal appropriately. Holes as small as ¼" is enough space for rodents to enter an area. If doors do not seal at the bottom, install a weather strip as a barrier to rodents
- g) Reduce harborages (cardboard boxes) where rodent may reside.

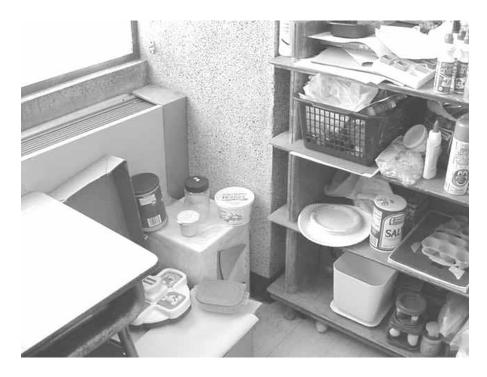
Re-use of food containers

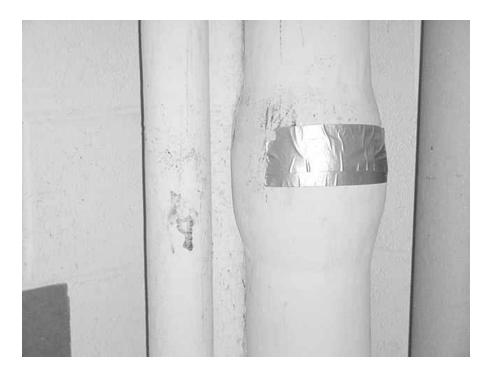
Damaged pipe insulation wrapped with duct tape was observed in one area (Picture 28). The pipe insulation may contain asbestos. The material should be inspected and, if applicable, be encapsulated by a licensed member of the GPS maintenance staff or other licensed professional contractor as soon as practicable.

Damaged pipe wrapping sealed with duct tape

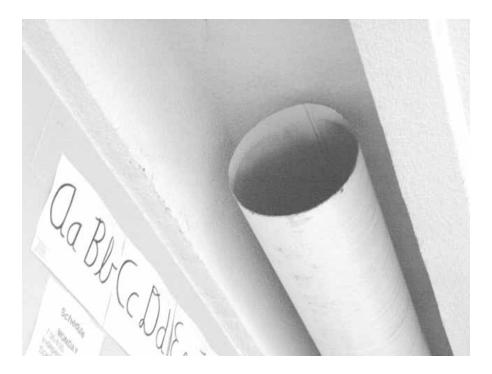
Open pipes and breaches as well as missing ceiling tiles were noted in a number of areas (Picture 29). Open pipes, breaches, and missing ceiling tiles can serve as pathways for dust, dirt, odors and other pollutants to move into occupied areas. A number of exhaust/return vents were

Open pipe in classroom

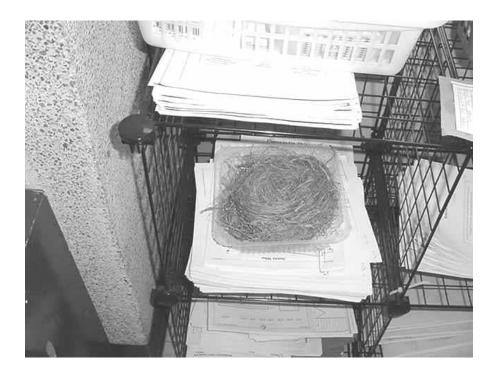
Inactive birds' nests were observed in some classrooms and reportedly serve as learning props (Picture 30). Birds' nests can contain bacteria and may also be a source of allergenic material. Nests should be placed in resealable bags to prevent aerosolization of allergenic material. These items should also be located away air streams.

Nests

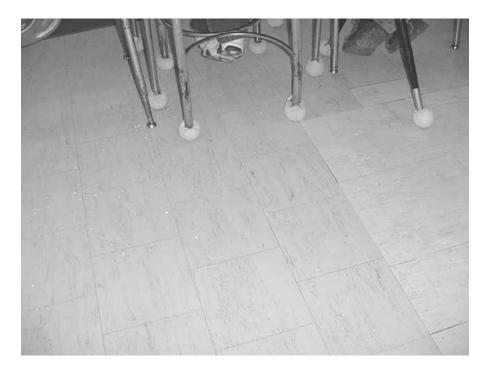
Lastly, in an effort to reduce noise from sliding chairs, tennis balls had been sliced open and placed on chair legs (Picture 31). Tennis balls are made of a number of materials that are a source of respiratory irritants. Constant wearing of tennis balls can produce fibers and off-gas VOCs. Tennis balls are made with a natural rubber latex bladder, which becomes abraded when used as a chair leg pad. Use of tennis balls in this manner may introduce latex dust into the

school environment. Some individuals are highly allergic to latex (e.g. spina bifida patients) (SBAA, 2001). It is recommended that the use of materials containing latex be limited in buildings to reduce the likelihood of symptoms in sensitive individuals (NIOSH, 1997). A question and answer sheet concerning latex allergy is attached as Appendix B (NIOSH, 1998).

Tennis balls on chair legs

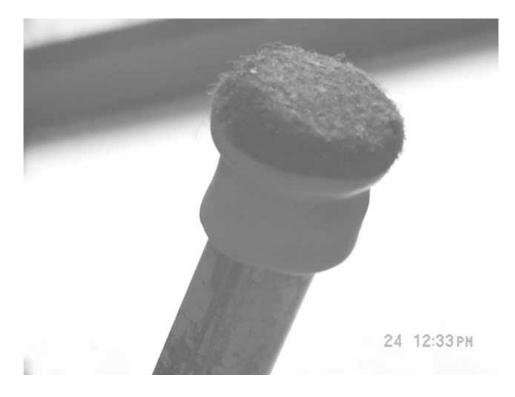
"Glides" for Chair Legs that can be used as an Alternative to Tennis Balls
